Evaluation of a Failed Heart Valve Bioprosthesis Using Microcomputed Tomography

DOI: 10.17691/stm2017.9.3.02

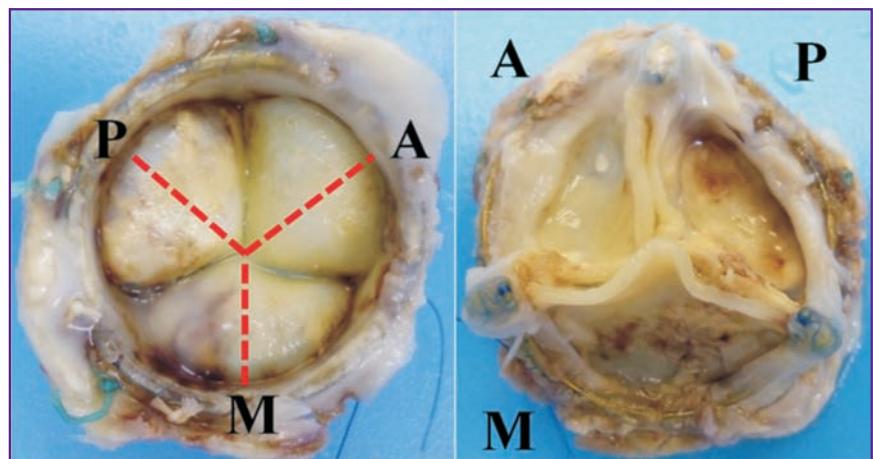
Figure 3. Explanted failed bioprosthesis (the view on the inflow and outflow side): A: anterior leaflet; M: medial leaflet; P: posterior leaflet; red dot line shows a scheme of histological sections

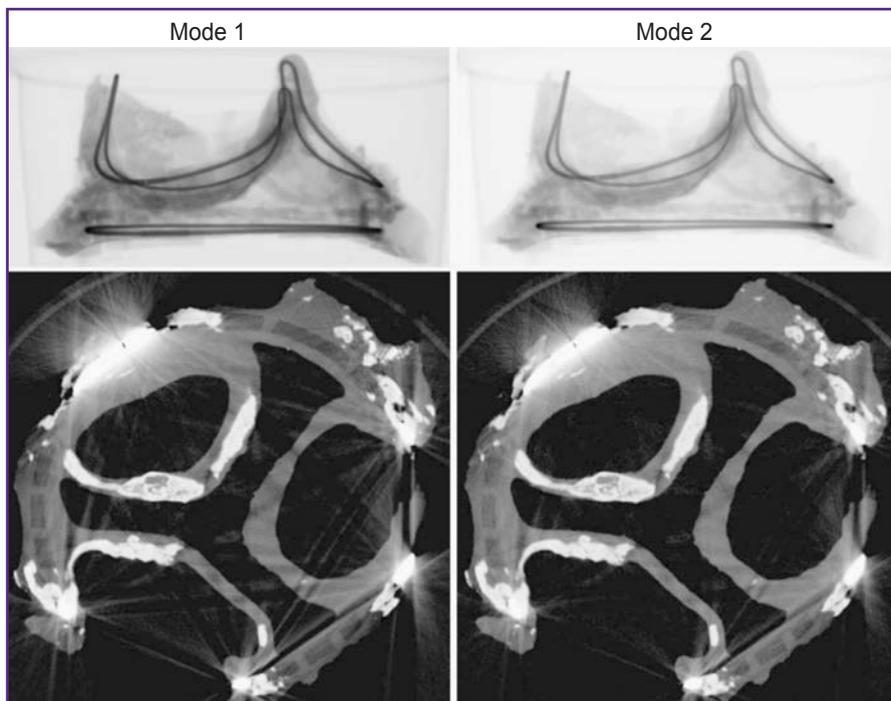
Microcomputed tomography. Initially, accelerating voltage of an X-ray apparatus was chosen as 80 kV. However, under these conditions, typical artifacts appeared on tomograms due to metallic components in a bioprosthesis structure [17]. Voltage was increased up to 140 kV that partly compensated the artifacts;

however, the contrast of the low-absorption components decreased (Figure 4).

Figure 4. Shadow view of the valve in accelerating voltage of the radiological apparatus 80 kV (mode 1) and 140 kV (mode 2) and corresponding tomograms

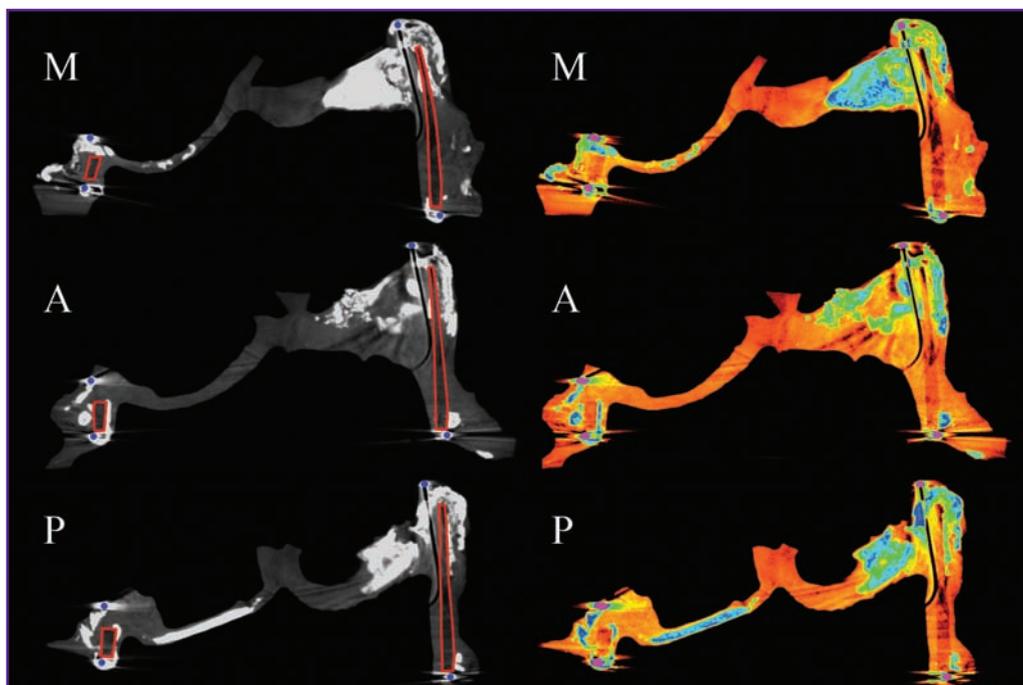
The grayscale tomograms and pseudo-color images taken during the experiment demonstrated the main location of the densest calcifications in the tissues of the posterior and medial leaflets, with the anterior leaflet being calcification-free (Figure 5). The calcification thickness in the posterior leaflet dome was 0.92 mm. The medial leaflet had several calcifications in the section located in the leaflet dome and base, maximum thickness being 1.68 mm. The anterior leaflet thickness in the free border was 1.57 mm, in the dome: 1.05 mm.

The medial section (M-section) clearly demonstrated asymmetry of the leaflet free edge, and therefore, the impaired geometry of the coaptation zone: the coaptation zone height was 2.14 mm versus 3.42 and 3.12 mm for posterior and anterior leaflets, respectively.

Figure 5. Tomograms corresponding to histological sections and agreed notation of leaflets: A: anterior leaflet; M: medial leaflet; P: posterior leaflet; on black and white films the blue color indicates the contour of a nitinol wire frame, the red color shows the polypropylene frame contour

The least curvature radius in the posterior leaflet was 22.0 mm, the angle of leaflet deflection was 22.7°. The same parameters for the medial and anterior leaflets were 6.15 mm, 30.9° and 7.20 mm, 26.0°, respectively.

The posterior-anterior rack of the wire frame had the least inclination angle: 73.4° (the rack was deformed

to the utmost), while the angle of the other racks was nearly the same: 80.0° (media anterior) and 79.7° (posterior-medial).

The frame diameter in all three sections slightly deviated from the initial one — 30.48 mm: 28.96 (P-section), 30.68 (M-section) and 30.22 mm (A-section),

i.e. the frame was not apt to have elliptical deformity (See Figure 5).

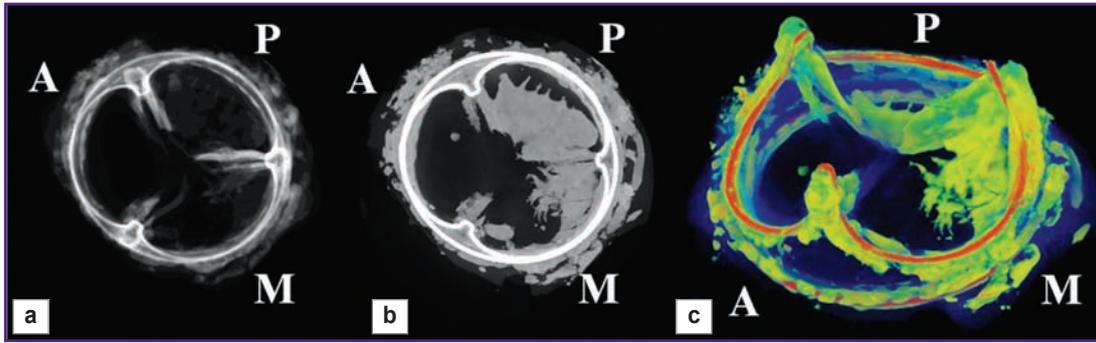
Figure 6. The marked areas with massive calcifications:
 (a) using 2-dimensional averaged view; (b) using 2D views of maximum intensity; (c) using 3D false color volume rendering; A: anterior leaflet; M: medial leaflet; P: posterior leaflet

The averaged 2D projection and the maximum intensity projection obtained through the study enabled to distinguish the areas with marked calcinosis (Figure 6). The posterior leaflet underwent the maximum changes, while the medial leaflet was affected on the side of the posterior-medial rack. Moreover, the volume rendering enabled to show clearly the calcifications in the area of the frame racks.

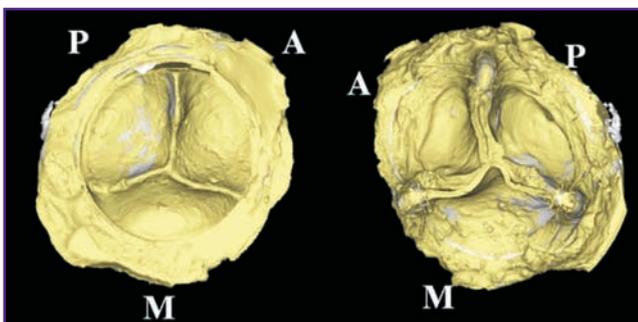
In accordance with the obtained grayscale histogram (16-bit grayscale ranging from 0 to 65,535), there were found two main peaks within the range of 800–3,700 — for biomaterial and polypropylene frame, 3,700–10,000 — for calcifications. The range of 10,000–65,535 corresponded to the wire frame. Segmentation and subsequent 3D models were constructed in accordance with these ranges (Figure 7).

The following values were obtained after measuring the volume of the segmented objects: total calcification volume was 1,499.68 mm³, the wire frame volume was 67.76 mm³, the volume (net of polypropylene frame) was 4,918.5 mm³. Thus, calcium/biological tissue ratio was 0.305. The total area of calcification network surface was 4,640 mm².

Figure 7. 3D model of a failed heart valve bioprosthesis obtained by micro-CT data reconstruction:
 A: anterior leaflet; M: medial leaflet; P: posterior leaflet; yellow color: biological material; white color: calcification

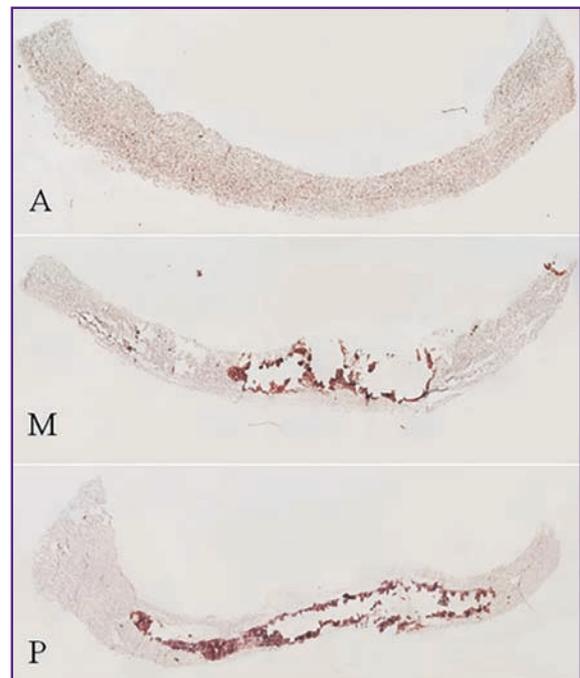
Figure 8. Cryostat sections of bioprosthetic leaflet central part:

A: anterior leaflet; M: medial leaflet; P: posterior leaflet; the free border is to the left, the leaflet base is to the right; the specimen being alizarin red stained; calcification of brown color; ×50

Histological examination. All the leaflets were thickened and lost elasticity. Initial tissue thickness was found to be preserved at the leaflet base. The central part of the posterior and medial leaflets was revealed to have large calcifications, 8.0 and 4.84 mm in length, respectively, localized in the leaflet dome (Figure 8). The maximal thickness of the calcified areas was found in the posterior and medial leaflet dome, it accounting to 0.89 (0.88–1.0) and 1.64 (1.59–1.72) mm, respectively. The calcification thickness varied from 0.3 to 0.68 mm. In addition, the calcification was found at the base of the

medial leaflet attachment to the frame, the calcification having no localization connection with the leaflet dome. The anterior leaflet in the central part had no calcification signs, its thickness in the free edge and the dome was 1.5 (1.47–1.54) and 0.96 (0.94–0.97) mm, respectively.
