Evaluation of a Failed Heart Valve Bioprosthesis Using Microcomputed Tomography

DOI: 10.17691/stm2017.9.3.02

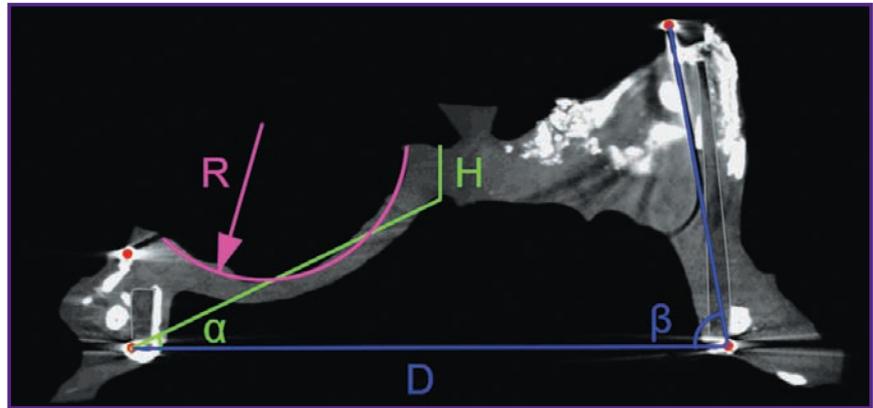
values, the measurements, as well as the grid were performed using software Mimics (Materialise, USA). When measuring the prosthesis deformities in tomograms corresponding to the planes of histological sections, we recorded the following parameters: H — coaptation zone height, α — angle of deflection of the leaflet, R — leaflet curvature radius, D — frame diameter, β — the inclination angle of the prosthesis wire frame rack (Figure 2).

Figure 2. The main parameters measured on the tomograms: H : coaptation zone height; α : the leaflet deflection angle; R : the leaflet curvature radius; D : the frame diameter; β : the inclination angle of the prosthesis wire frame rack
