A Novel Technique for Preparation, Staining, and Visualization of Tissue with Metal Implants and Extraskeletal Calcification Areas

DOI: 10.17691/stm2020.12.4.02 Received September 11, 2019

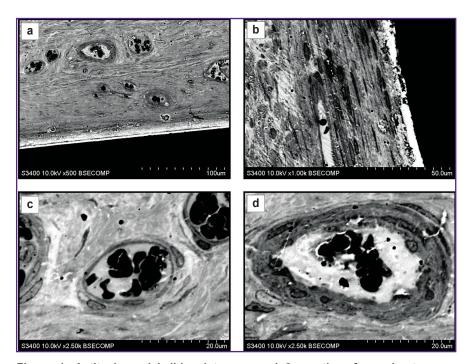
Figure 1. A titanium nickelide plate removed 2 months after subcutaneous implantation to a Wistar rat

Visualization of the barrier between the plate and tissues ((a) ×500; (b) ×1000) and newly formed vessels ((c), (d) ×2500)

implants, in particular, on the classical model of subcutaneous implantation of medical device prototypes. For example, it is almost impossible to obtain sections of the extracted samples with surrounding tissues due to substantial thickness of titanium nickelide plates (1 mm). Consistent use of grinding and polishing makes it possible to achieve high preservation of biological tissues without damaging the implant (Figure 1 (a), (b)). The fine structures of the sample are visualized in more detail with the increased magnification. In particular, 1000-fold magnification (Figure 1 (c)) makes it possible to evaluate the structural features of tissues and the structure of cells adjacent to metal. The presence of a small slit-like space containing small electron-dense granules was found immediately at the site of contact. Formation of the slit and granules was likely to be

an artifact associated with the processes of harvesting and preparing the material. Further, a layer of dense connective tissue represented by fibrocytes with a typical structure of nuclei and cytoplasm was identified reliably in the backward direction from the implant. A characteristic feature of this portion of the sample was the absence of immunocompetent recipient cells. By the time of sampling, the material showed complete biocompatibility.

Abundant loose connective tissue was observed behind the layer of dense connective tissue, and the boundary between them was distinct. It should be noted that large blood vessels were present in the layer of loose connective tissue, in contrast to dense connective tissue (see Figure 1 (c)). As a rule, the maximum number of vessels was detected near the site of contact between loose and dense connective tissues, but the vascular density got lower with the increasing distance from the implant. Large blood vessels had a typical structure (Figure 1 (d)) and showed differences in the structure of the membranes. The endothelial layer was observed in all vessels, though, in some of them there followed several layers of rounded cells with a cytoplasm having increased electron density. Further increase in magnification allows investigating the structure of the cytoplasm and nuclei in detail, making it possible to increase reliability of morphological identification of cells.

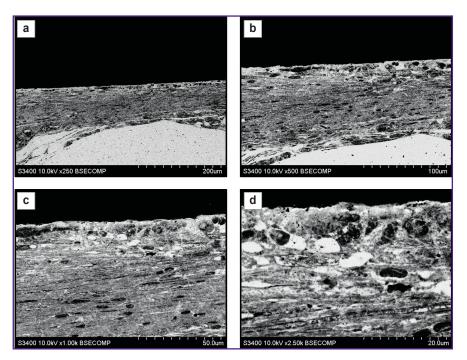
Figure 2. Perforated plate made of patented original titanium alloy, removed 2 months after intracranial implantation to New Zealand white rabbits Visualization of the barrier between the plate and tissues ((a) ×250; (b) ×500) and differentiation of connective tissue into two layers: (c) underlying dense layer containing elongated cells with oblong nuclei, ×1000; (d) the layer adjacent to the plate, loose with rounded intercellular spaces, ×2500

after cranioplasty, it was observed that there was a connective tissue layer formed around the structural elements of the plates. At low magnifications (Figure 2 (a), (b)), there was detected a connective tissue layer formed by elongated cells parallel to the surface of the plate. At high magnifications (Figure 2 (c), (d)), two layers were distinguished in the composition of the tissue. In the layer immediately adjacent to the plate, there was a loose arrangement of cells with large transparent rounded intercellular spaces, and following it there was a layer of elongated cells with oblong nuclei and moderate density cytoplasm. Transition between the layers was gradual. In the examined sample area, there was firm adherence of cells to the patch material. Adjacent cells had various shapes (predominantly rounded) and contained small granules in the cytoplasm.

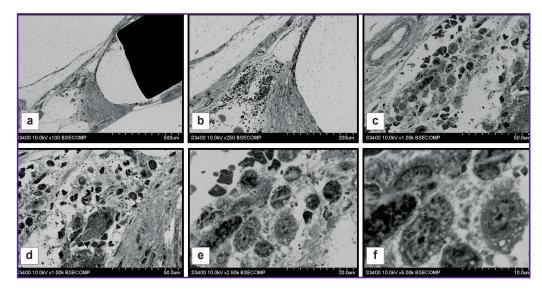
Figure 3. Perforated plate made of patented original titanium alloy, removed 1 month after intracranial implantation to New Zealand white rabbits

Connective tissue capsule forming around the plate: (a) general view of the plate with surrounding tissues, ×100; blood vessels and multiple cells of the surrounding tissue: (b) ×250; (c) ×1000; numerous macrophages in the focus of productive inflammation: (d) ×1000; (e) ×2500; (f) ×5000

in this region, which contained no structural elements and was surrounded by a thin layer of connective tissue connected to a tissue array that was spaced from the end surface (Figure 3 (a)). Blood vessels and various

types of cells (Figure 3 (b), (c)), especially macrophages (Figure 3 (d)–(f)), were present in this tissue. Macrophages had a typical structure and contained vacuoles with transparent content (see Figure 3 (e), (f)). The presence of macrophages is likely to indicate the presence of productive inflammation caused by implantation of artificial biomaterial.

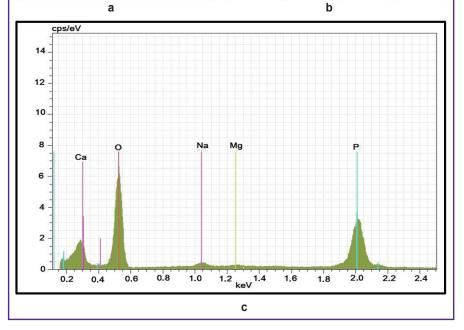
Figure 4. Structure, cellular environment, and chemical composition of the mineralization area as part of atherosclerotic plaques:

(a) calcification with the surrounding tissues, $\times 500$; white rectangles with numbers (1, 2, 3) indicate the areas where the elemental composition was identified (segment 1 — calcification itself; segment 2 — dense connective tissue adjacent to calcification; segment 3 — loose connective tissue abundant in phospholipids); (b) elemental composition of the areas marked in the micrograph; (c) a diagram of X-ray microanalysis of segment 1 (calcification)

of calcium phosphate or another mineral, which is important for assessing the mineral maturity, the calcification site age, and can affect the stability of the atherosclerotic plaque. Evaluation of elemental analysis results for the three sites (Figure 4 (b), (c)) showed that calcium, phosphorus, oxygen, sodium, magnesium, and osmium were present in them.

Oxygen, calcium, and phosphorus prevailed in the mineralization area (segment 1), which indicates its phosphate-calcium nature. It should be noted that osmium used for post-fixation of tissue caused no artifact contamination of calcium inclusions and, consequently, biased results of elemental analysis.

In the adjacent connective tissue calcification site (segment 2), the amount of calcium and phosphorus was about 0.5%, which is a high level for biological tissue and it may reflect active metabolism of these elements in

smooth muscle cells. In addition, certain osmium content was detected in this segment (about 4%).

In loose connective tissue (segment 3) with a high electron density, the calcium content was 8 times lower than in the connective tissue adjacent to the mineralization area, but the amount of phosphorus and osmium was 4 times higher. The high content of these elements suggests that in this case, the high electron density of the area results from presence of a large number of phospholipids characteristic of atherosclerotic plaques, since they are highly osmiophilic and contain phosphorus, but not calcium.

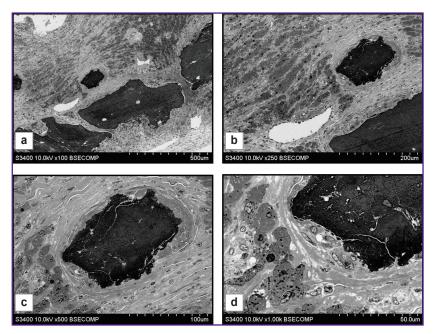
Figure 5. Mineralization areas with surrounding tissues as part of atherosclerotic plaques:

(a) general view of calcifications and their location in the plaque structure, ×100; (b) location of a newly formed large blood vessel close to calcification, ×250; (c) connective tissue capsule around calcification, ×500; (d) multiple cells of various structures close to calcification. ×1000

In cases where there is no need to study the elemental composition of samples, mineral inclusions can be identified based entirely on morphological features. The general structure of the object with the surrounding tissues and location of blood vessels are clearly visible

when studied at low magnifications (Figure 5 (a), (b)). Higher magnification (Figure 5 (c), (d)) makes the surroundings of the calcification area, its heterogeneous structure, its connective tissue capsule, and the structure of the surrounding cells visible in detail.

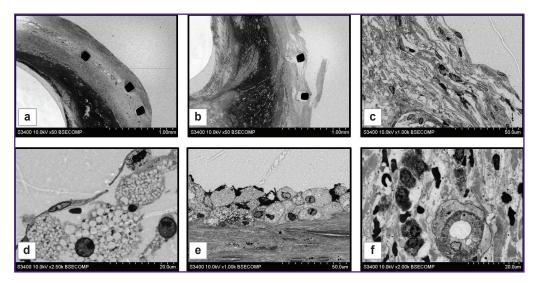
Figure 6. The structure of an atherosclerotic plaque formed in the carotid artery after stenting and restenosis development:

(a), (b) general view of the structure of the removed plaque containing the stent and mineralization areas, ×50; (c) partially disintegrated dense connective tissue with immunocompetent and connectivetissue cells, ×1000; (d) intact endothelial cells and foam cells located beneath them, ×2500; (e) a layer of foam cells and underlying dense connective tissue with slit-like spaces, ×1000; (f) a newly formed blood vessel in neointima with multiple cells located around, ×2000

The use of this method for examination of samples containing both metallic and mineral inclusions is of particular interest. In fact, atherosclerotic plaques that developed after stenting, have signs of restenosis contain mineral inclusions and (Figure 6 (a), (b)) can serve as an example. Careful sampling of the material ensured high preservation of the plaque layers. Supports of the stent surrounded by a layer of dense connective tissue were visualized clearly. In the direction peripheral to the vessel lumen, there was observed a layer of dense connective tissue, which was the remaining vessel media present in the vessel structure prior to stenting (see Figure 6 (a)). Between the stent elements, large blood vessels

with thin walls were observed. Deeper than the stent, in the direction of the vessel lumen, there was a thick layer of neointima with a different electron density in the radial direction (see Figure 6 (b)). The above figures show areas with high electron density, which can be

At higher magnifications, the cells present in the structure of the samples were well visualized. In particular, Figures 6 (c) and (d) show two different plaque portions in direct contact with the bloodstream and with intact endothelial layers. Endothelial cells had similar structure, but the underlying cells and tissues were different. Figure 6 (c) shows the segment where there was observed a layer of connective tissue under the endothelium, consisting of dense fibers between which there are cells described as smooth muscle cells and macrophages, based on morphological characteristics, these macrophages containing small light vacuoles and lysosomes. It is rather obvious that gradual destruction of dense connective tissue structure occurred in this area. In the variant presented in Figure 6 (d), loose tissue with large intercellular spaces was found under the endothelial layer. The cells adjacent to the endothelium had a rounded shape, round nuclei with a thin layer of chromatin adjacent to the nuclear membrane and diffuse arrangement in the central part of the nucleus. These cells were morphologically similar to foam cells.

In the direction peripheral to the vessel, the layer of foam cells was adjacent to partially preserved layer of dense connective tissue where cells and slit-like spaces were observed (Figure 6 (e)). The inner part of the neointima was heterogeneous. There were no cellular structures in one part of it, while newly formed blood vessels (the so-called vasa plaquorum), macrophages, smooth muscle cells were observed in other parts (Figure 6 (f)).
